**APPLICATION OF INFRARED  
THERMOGRAPHY TECHNIQUE FOR  
EVALUATION OF EXISTING CONCRETE  
STRUCTURES**

**By Tarun R. Naik, Shiw S. Singh, and John A. Zachar**

Report No. CBU-1997-08  
REP-307  
January 1997

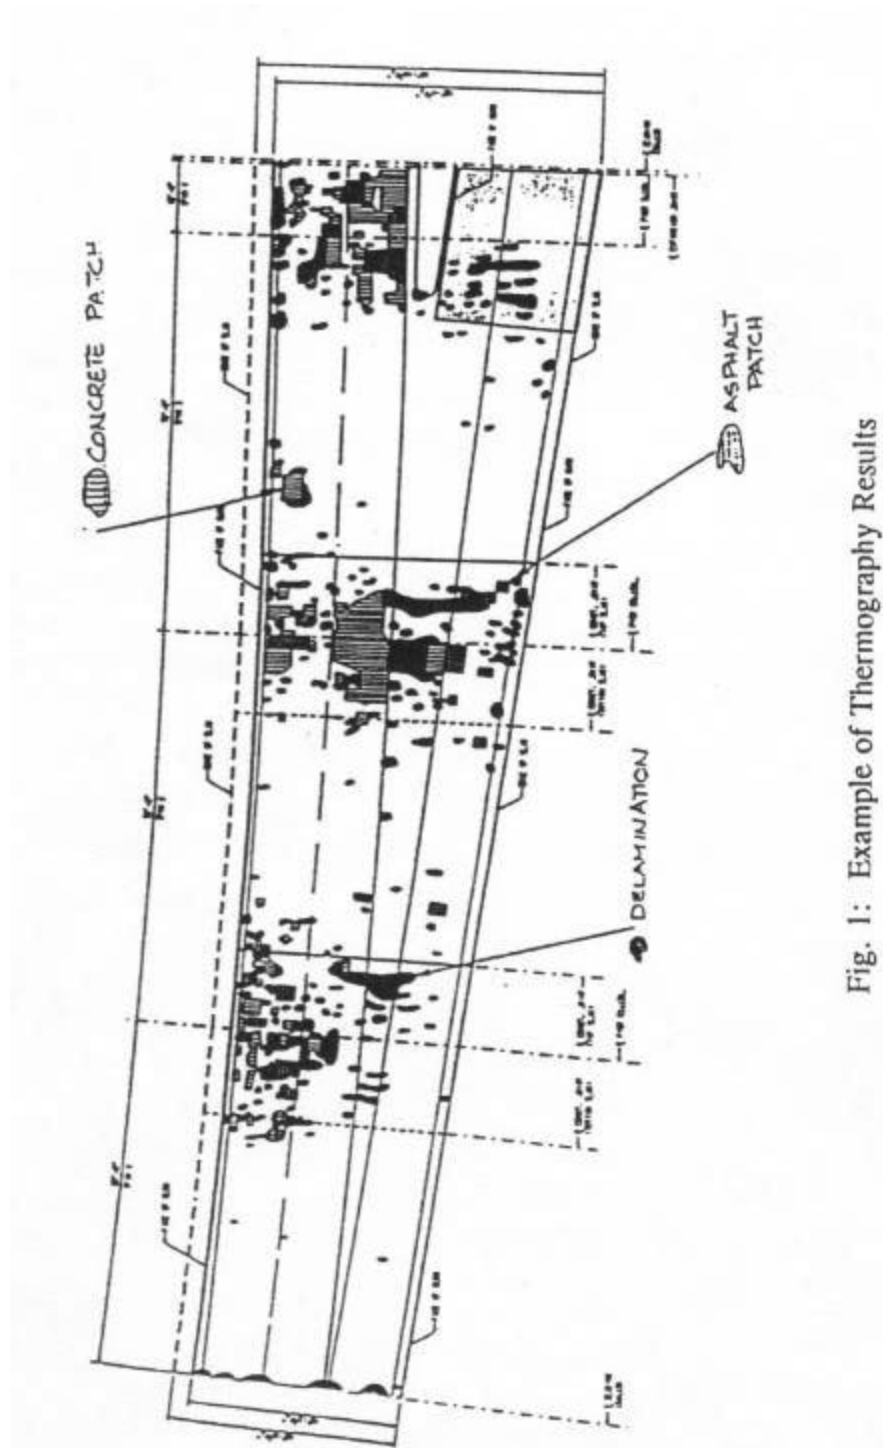
Fig. 1: Example of Thermography Results

Test result of this investigation showed several subsurface anomalies of the Zoo interchange bridge deck that were undetectable in visual inspection. A sample of the test results is presented in Fig. 1.

The present investigation showed numerous subsurface defects in the Zoo interchange bridge deck that were not noticed during visual inspection. It is recommended, based upon this study, that bridge decks, roads, etc. be scanned at regular intervals as a form of preventative maintenance. A database should be created and maintained of how the deterioration of the pavement progresses from year to year. In such systematic evaluation, any pattern of deterioration could be discovered before it reaches critical levels needing massive repairs. Similarly, trends might be found relating severity of weather, amount of deicing salt used, traffic counts, and other factors leading to the deterioration of the pavement. With an accurate database, road repair budgets and plans for preventative maintenance could be prepared with greater accuracy.
